## **CLIMATE CHANGE MITIGATION AND ADAPTATION**

# CAUSES OF WATER LEVEL DRAWDOWN ON LAKE MWERU WANTIPA, ZAMBIA

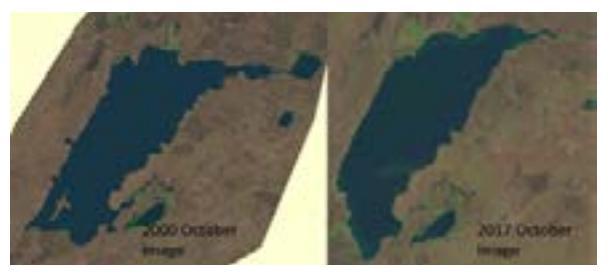
Figure 1. LandSat7 images for Lake Mweru Wantipa in October 2000 and October 2017 (the 2 images are not of the same scale)

Satellite imagery (LandSat7) was used to compare the size and shape of the lake in October 2000 and October 2017, see Fig. 1.

The overall analysis of the results showed that anthropogenic activities led to the blockage of water ways transferring water in the tributaries. The blockage was due to siltation caused by erosion as a result of deforestation of the riparian zones and wrong fishing methods.
